GM CONVEYOR HEALTH ASSESSMENT

EXECUTIVE SUMMARY

OCC Systems completed inspection on portions of the OH P&F conveyor to demonstrate how the Predictive Database Method can be used to identify and develop a prioritized plan for the replacement of conveyor due to critical wear as determined by stress and deflection calculations.

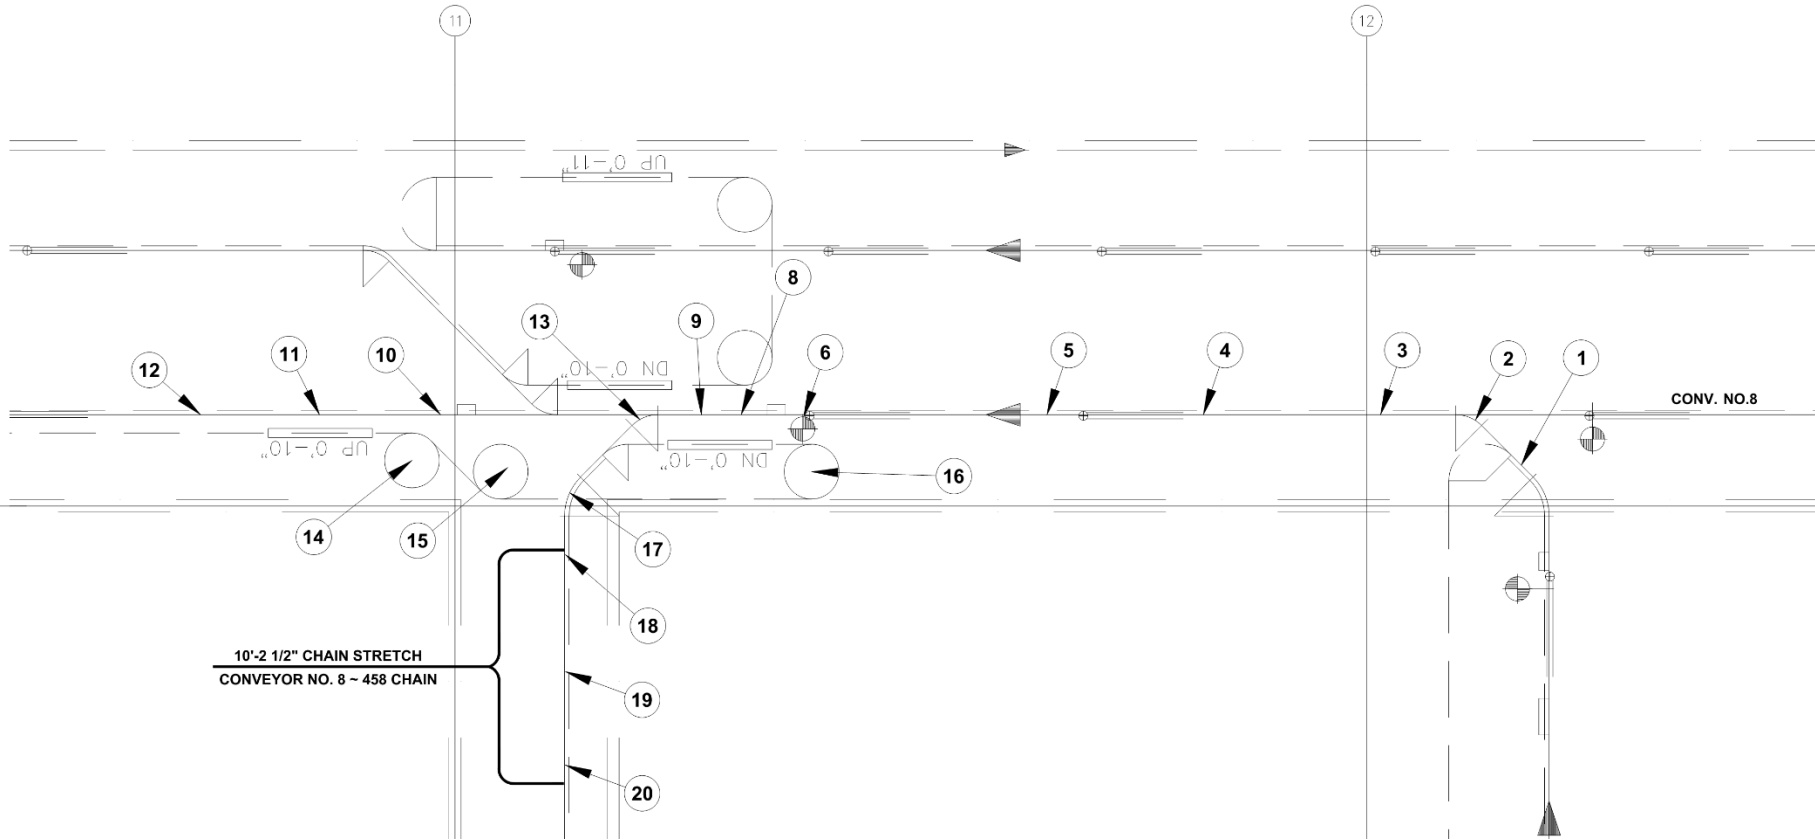
HEALTH ASSESSMENT AREA 1 POINT MAP

All of the track and components in Area 1 showed minor wear and were assigned a #3 priority.

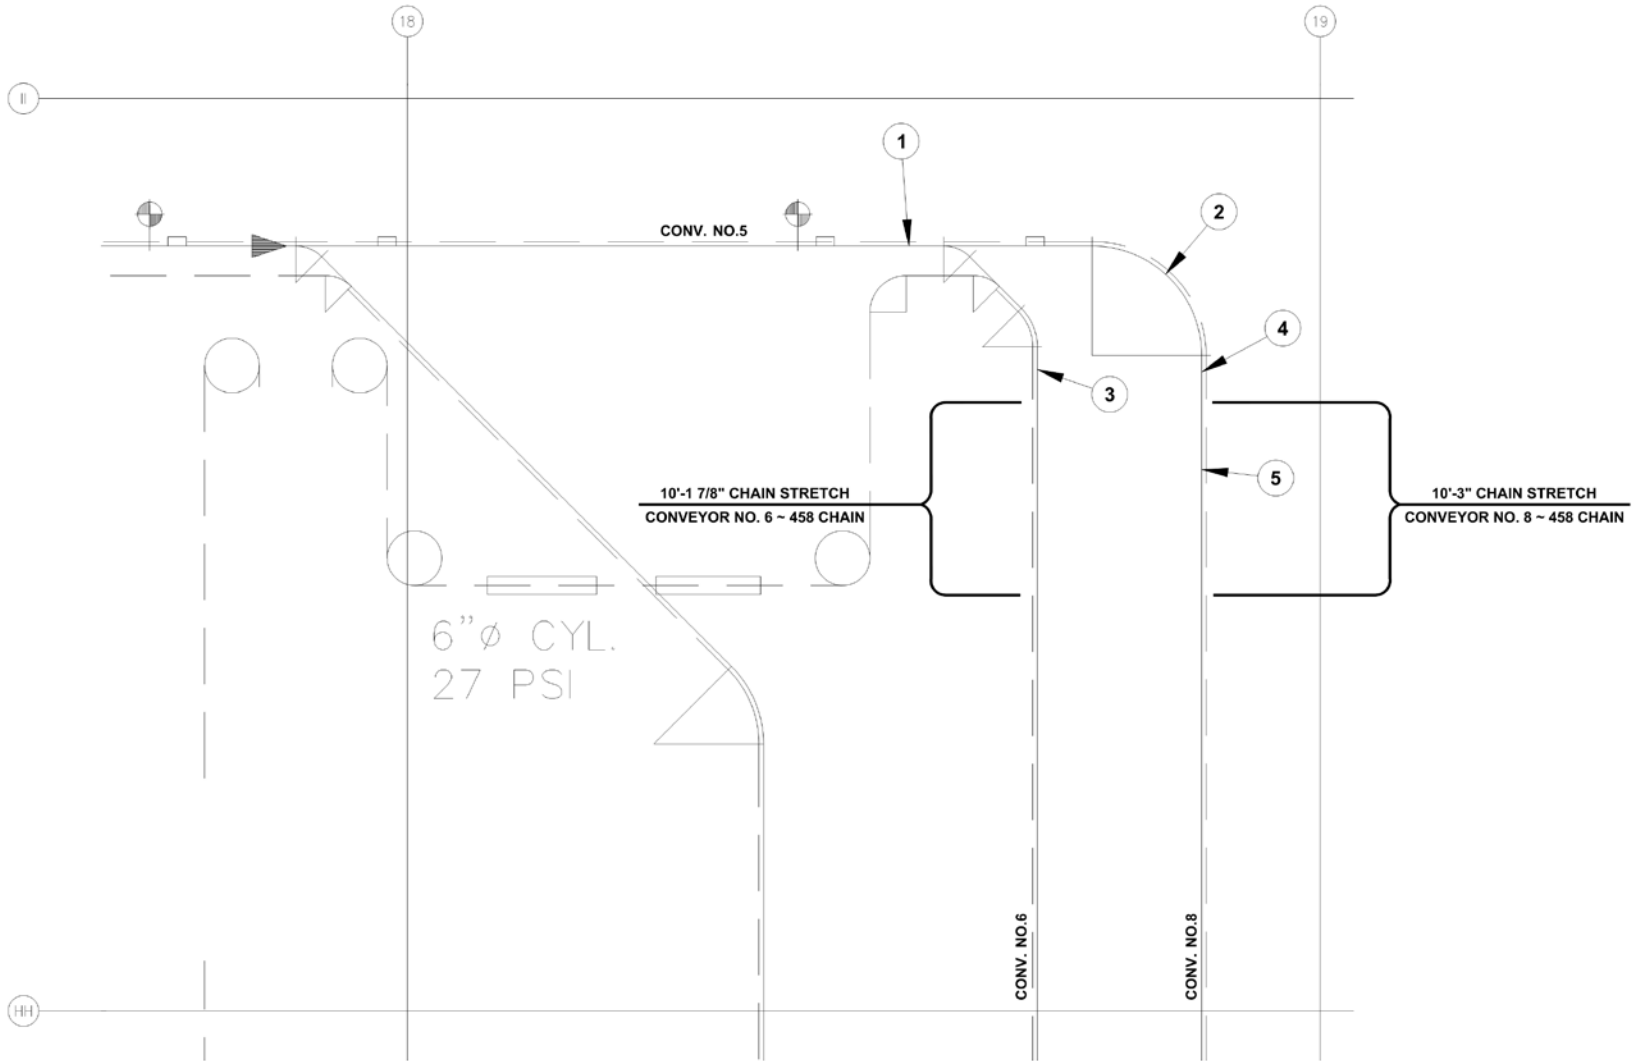
HEALTH ASSESSMENT AREA 2 POINT MAP

In Area 2, Item #3 was approaching the recommended values and was assigned a #2 priority to be monitored on a regular basis. Items #4 and #5 exceeded the recommended values and were assigned a #1 priority.

0.125" to 0.250"	Yellow	Monitor												
0.250" or more	Red	Exceeds limits, replace or repair												
% Track Wear values (at wheel tread):														
0 - 25%	Green	Good										Within recommended limits, low priority =		3
26 - 32%	Yellow	Monitor										Approaching recommended limits, medium		2
33% or more	Red	Exceeds limits, replace or repair										Exceeds recommended limits, Highest Priority		1
Track Gap				Track Wear								Summary		
Loc #	Track Gap	Extra Gap	Track Status	LH Flange Thick	LH Flange Wear	LH Wear %	LH Track Status	RH Flange Thick	RH Flange Wear	RH Wear %	RH Track Status	Comments	Replacement Priority	
1	1.760	0.0100	Good	0.290	0.023	7.200%	Good	0.270	0.043	13.60%	Good		3	
2	1.700	0.0500	Good	0.320	-0.008	-2.400%	Good	0.290	0.023	7.36%	Good	Twist in Rolled Track Component	3	
3	1.990	0.2400	Monitor	0.300	0.015	4.800%	Good	0.300	0.015	4.80%	Good		2	
4	2.000	0.2500	Excessive	0.300	0.015	4.800%	Good	0.340	-0.028	-8.80%	Good	Twist in Rolled Track Component	1

5	2.040	0.2590	Excessive	0.300	0.015	4.800%	Good	0.200	0.113	36.00%	Excessive		1

The items that are assigned a #1 priority are experiencing stress levels that exceed the recommended design limit, and therefore operating without the typical safety factors considered to be consistent with good industrial practice. While it is impossible to predict when component failures will actually occur, the priority illustrates the order the components are most likely to fail. The replacement timeline is to be determined by GM based on ongoing inspections to monitor track wear, flange bending, available installation windows, and replacement component availability.
