GM CONVEYOR HEALTH ASSESSMENT

EXECUTIVE SUMMARY

OCC Systems completed inspection on portions of the OH P&F conveyor to demonstrate how the Predictive Database Method can be used to identify and develop a prioritized plan for the replacement of conveyor due to critical wear as determined by stress and deflection calculations.

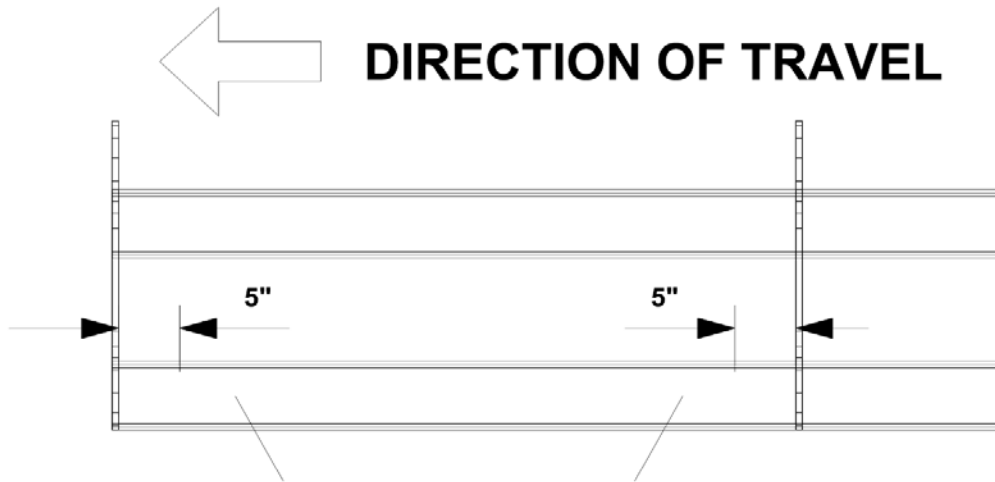
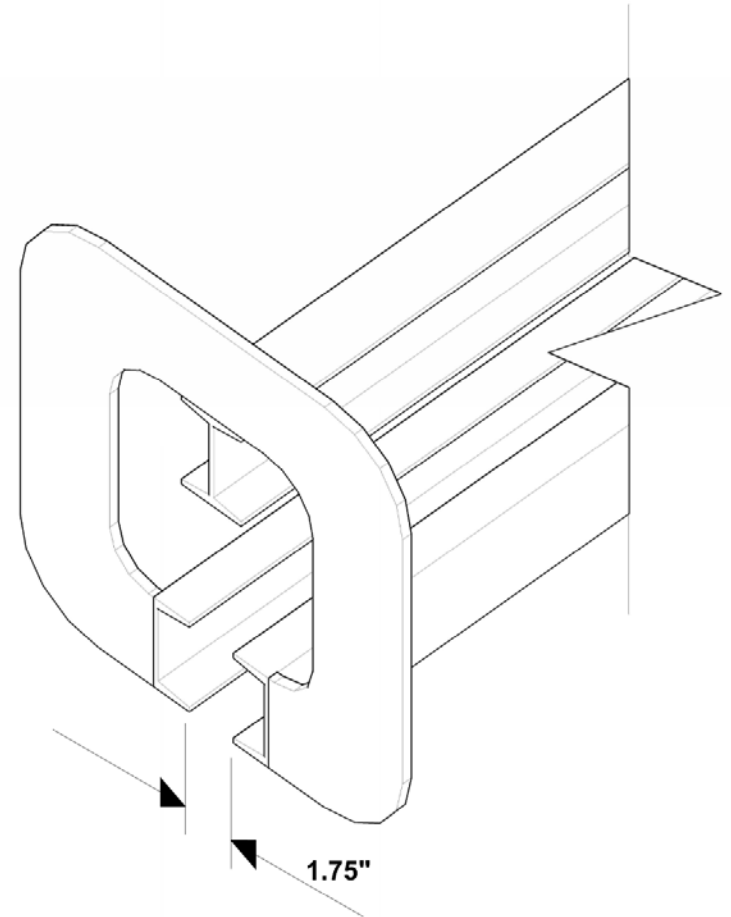
1. EACH TRACK GAP MEASUREMENT IS TAKEN APPROXIMATELY 5" BEFORE OR AFTER A YOKE.
2. EACH MEASUREMENT LOCATION IS ASSIGNED A NUMBER ON AREA 1 & AREA 2 OF THE HEALTH ASSESSMENT MAPS.
3. THE LOCATION NUMBERS ARE CROSS REFERENCED TO EACH AREAS TRACK GAP & TRACK WEAR CHARTS WITHIN THIS REPORT.

4. THE TARGET MEASUREMENT FOR NEW 4" CONVEYOR IS A TRACK GAP OF 1.75"

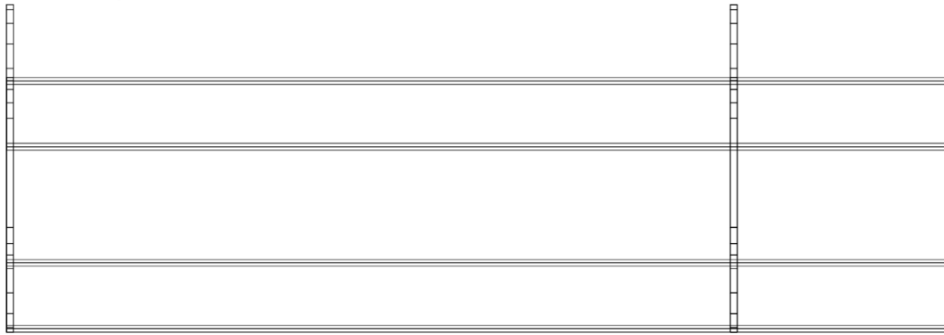
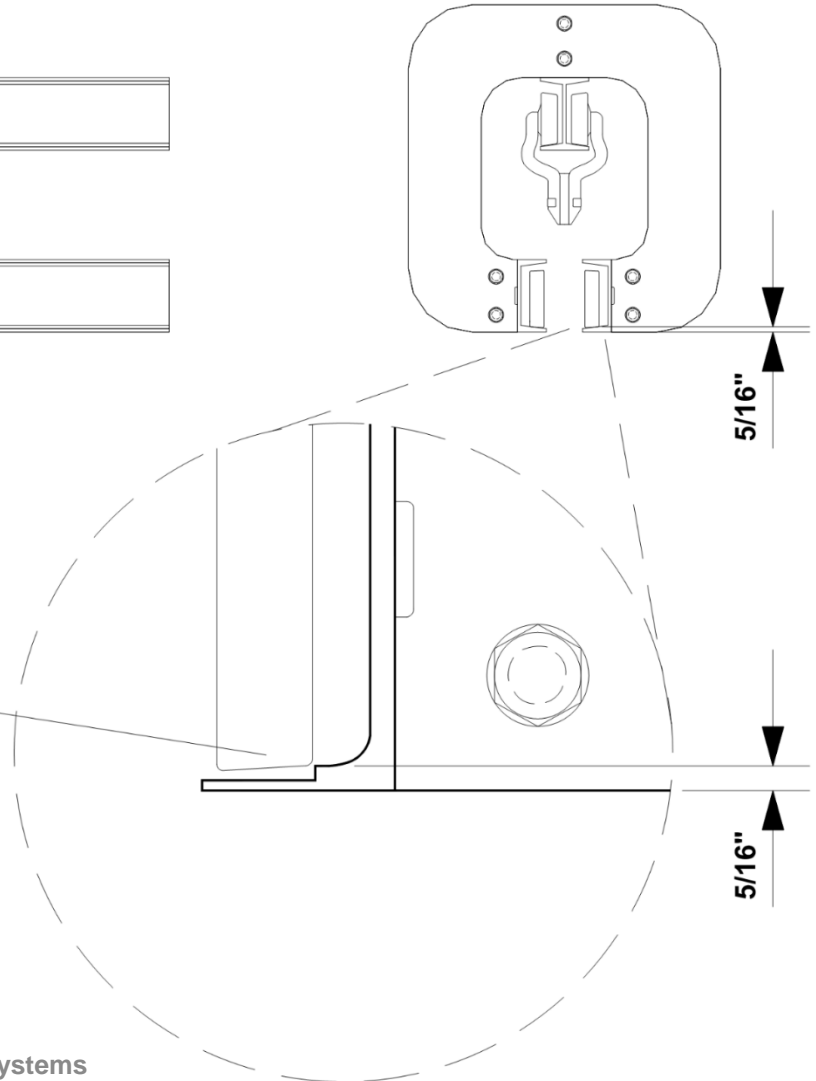
FLANGE THICKNESS AND WEAR

1. TRACK FLANGE THICKNESS IS MEASURED ON BOTH THE LEFT HAND AND RIGHT HAND SIDE OF THE RAIL FOLLOWING THE FLOW OF THE CONVEYOR.
2. THE AREA MEASURED IS AT THE WEAR STEP OF THE TROLLEY WHEEL
3. NEW CHANNEL (C4x5.4) MEASURES 5/16" AT THIS LOCATION.
